AFWAL-TR-79-3095
VOLUME II

ADVANCED RESIDUAL STRENGTH DEGRADATION RATE
MODELING FOR ADVANCED COMPOSITE STRUCTURES
VOLUME II - TASKS II AND III

Lockheed-California Company
Burbank, California

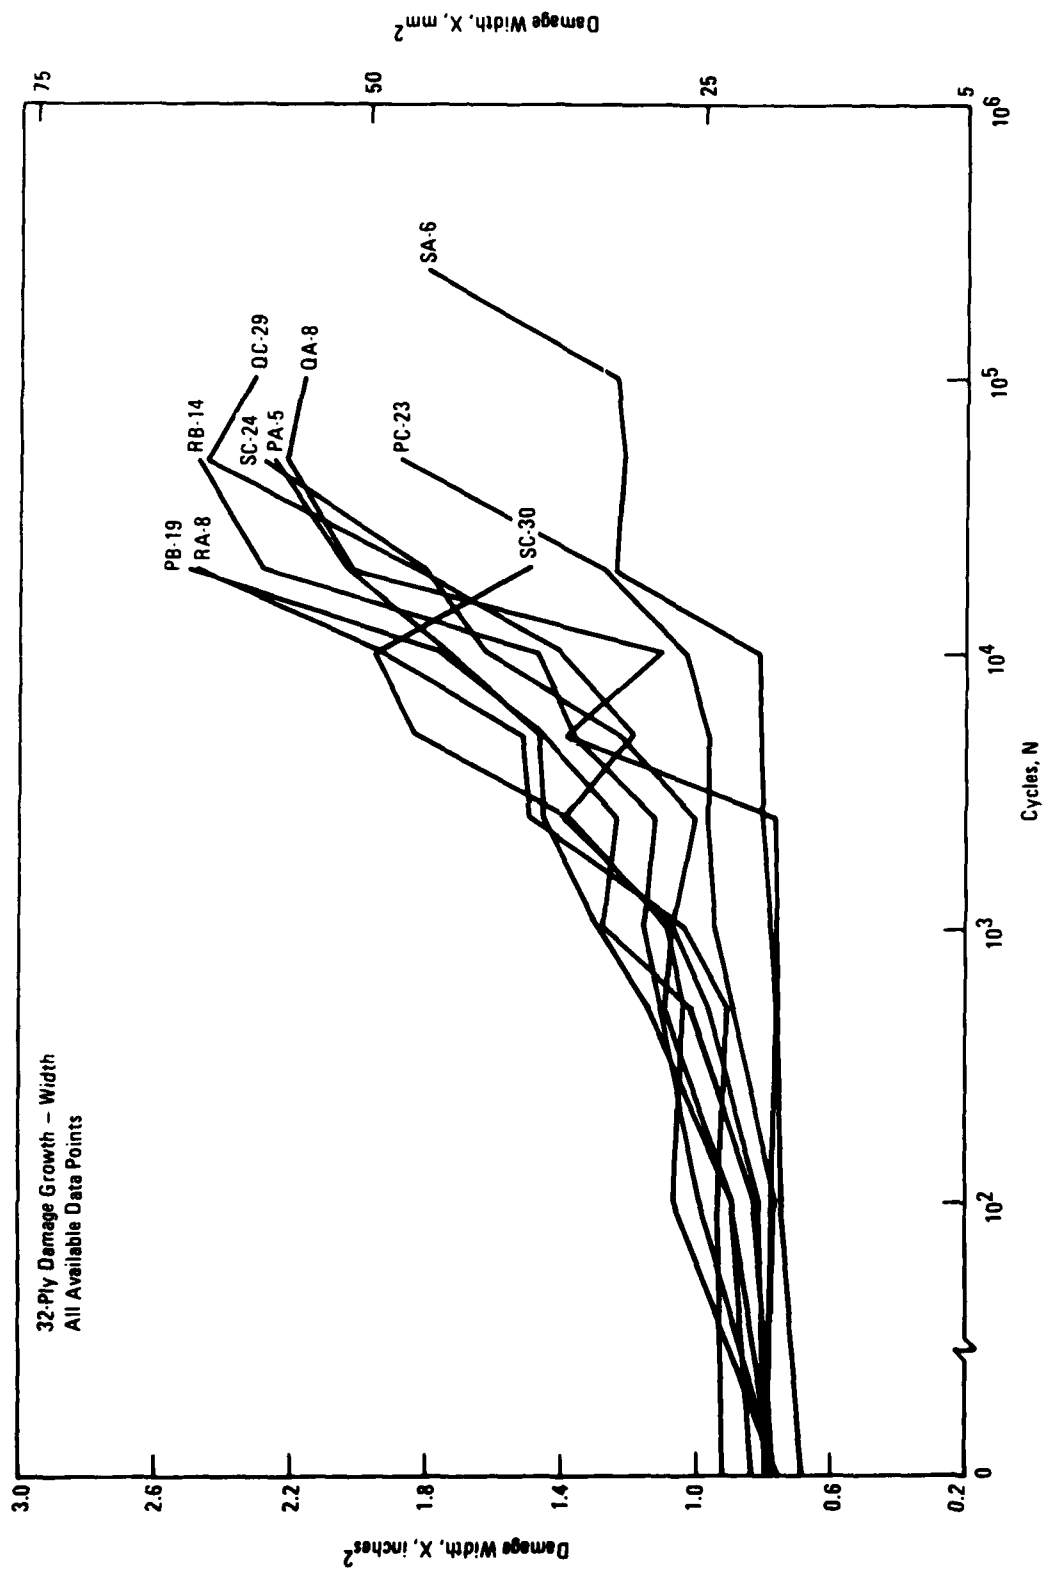
Figure 74b: Damage Growth in the Width Direction for the 32-Ply Fatigue Distribution Specimens (Specimens 11 thru 20)

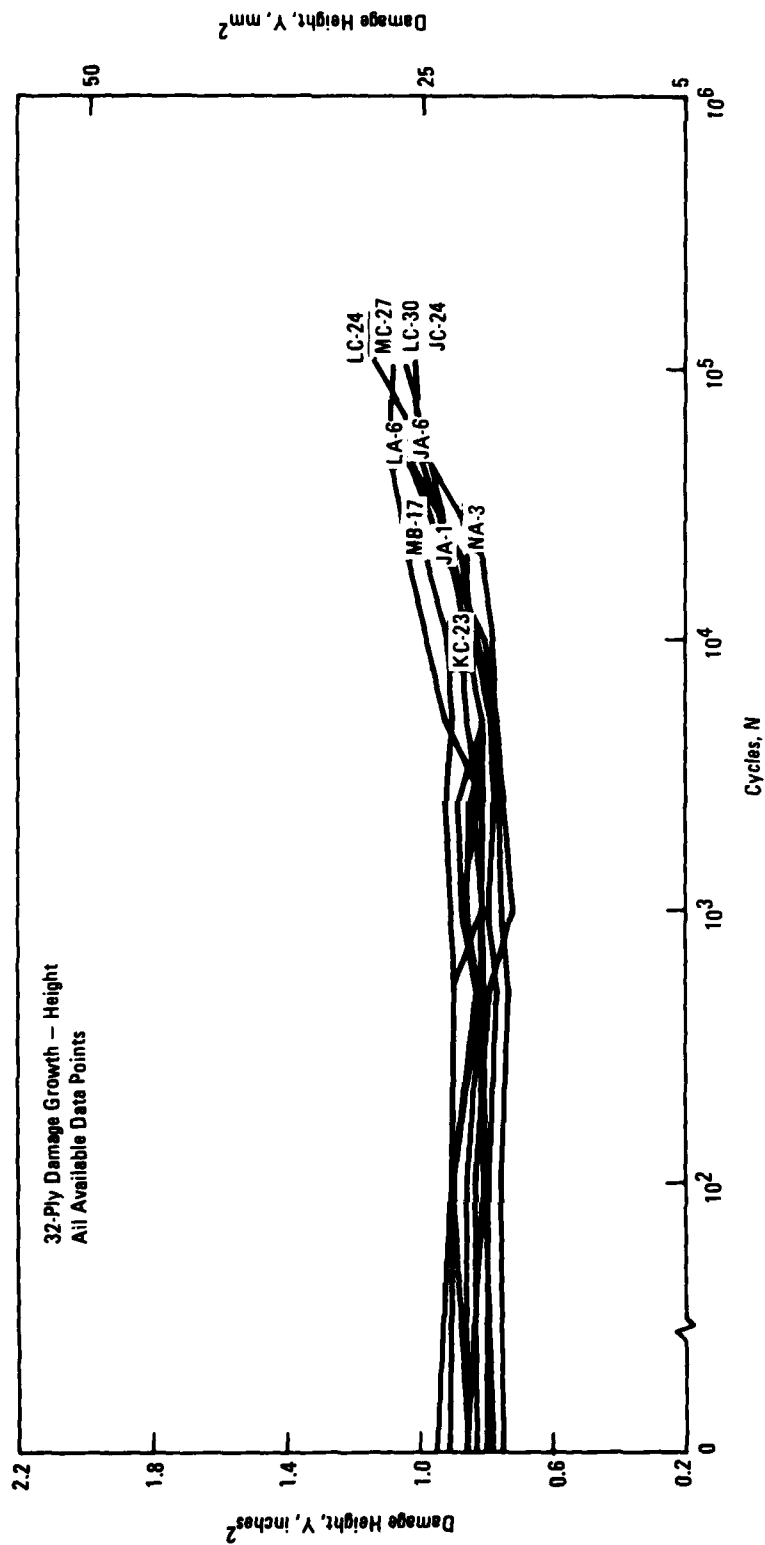
Figure 75a: Damage Growth in the Height Direction for the 32-Ply Fatigue Distribution Specimens (Specimens 1 thru 10)

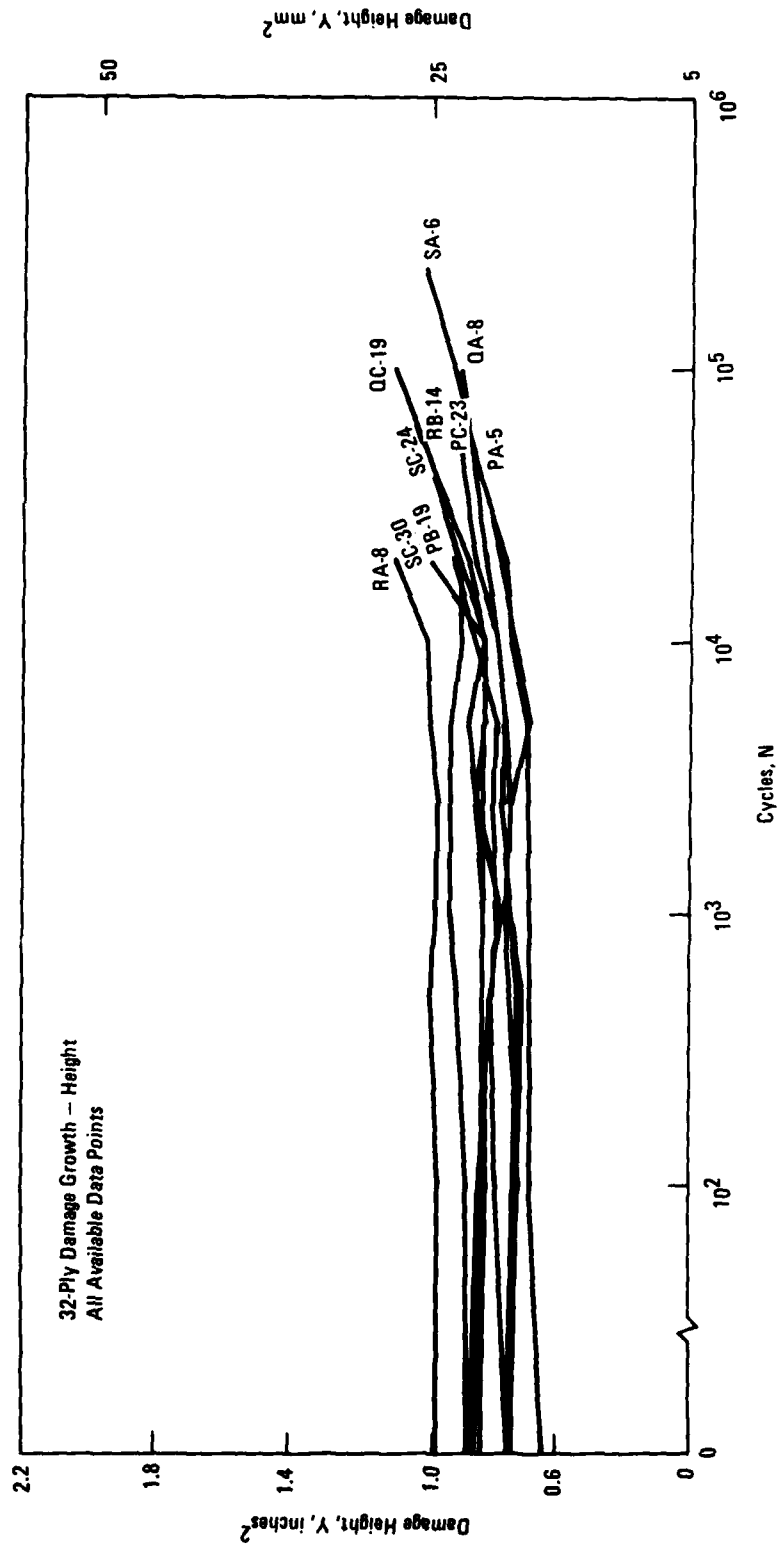
Figure 75b: Damage Growth in the Height Direction for the 32-Ply Fatigue Distribution Specimens (Specimens 11 thru 20)

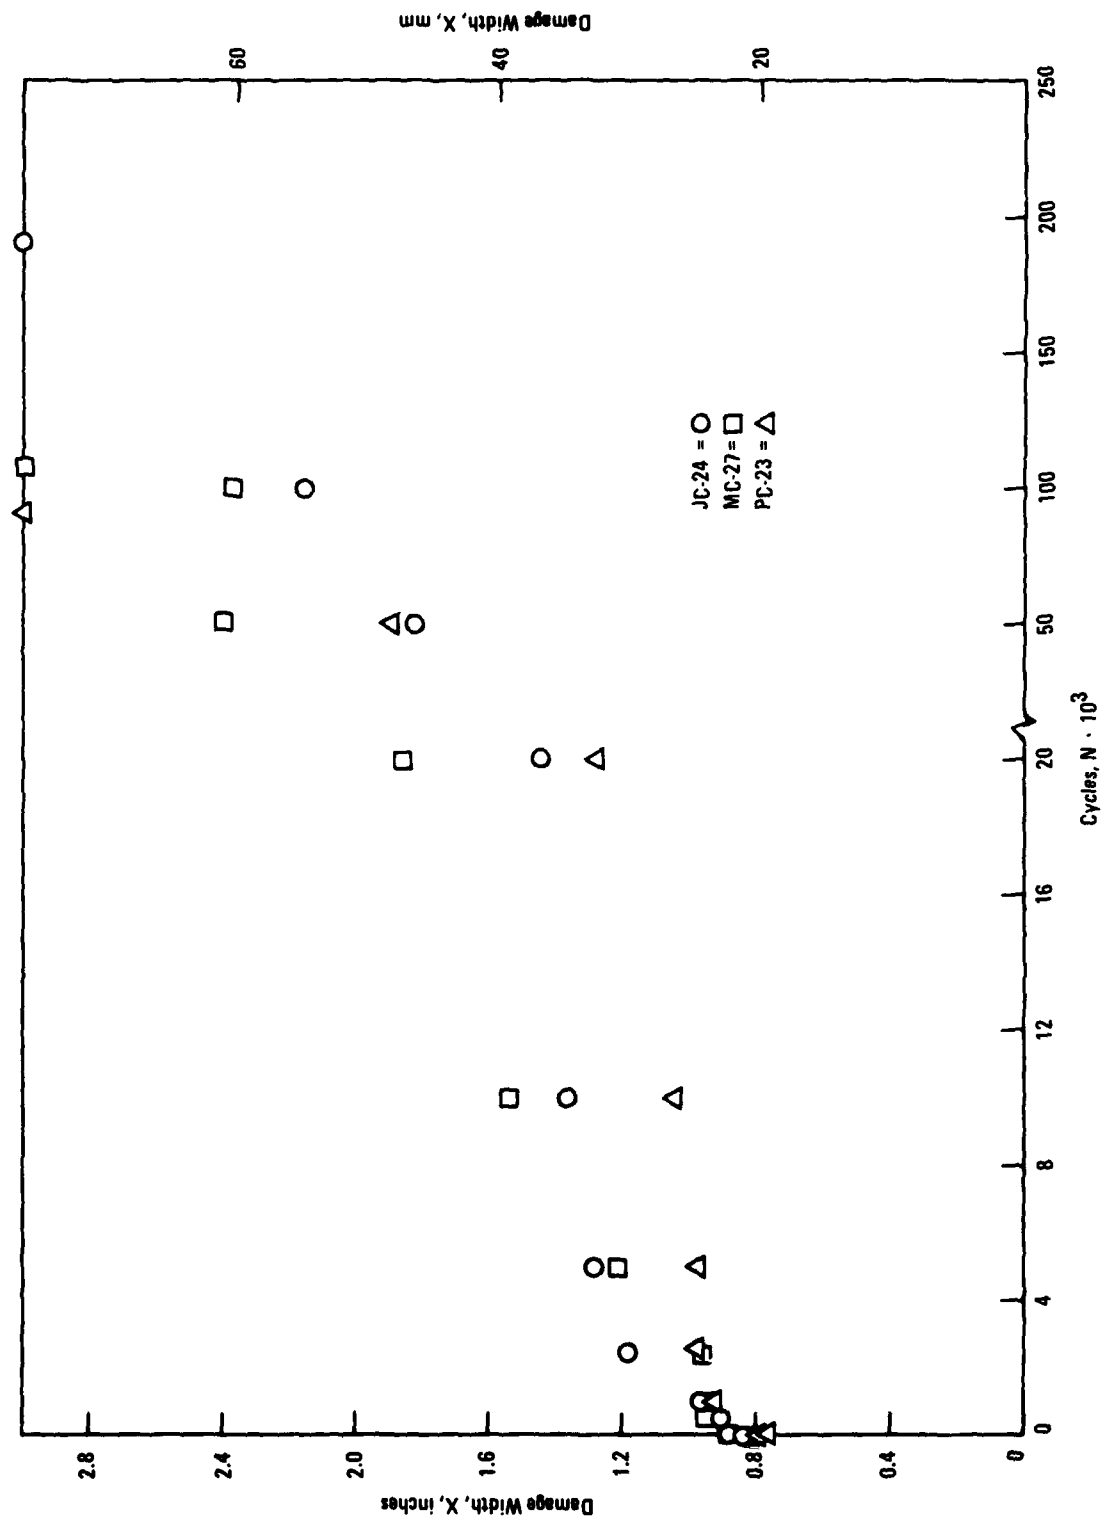
Figure 76: Typical Damage Growth of 32-ply Laminate Specimens

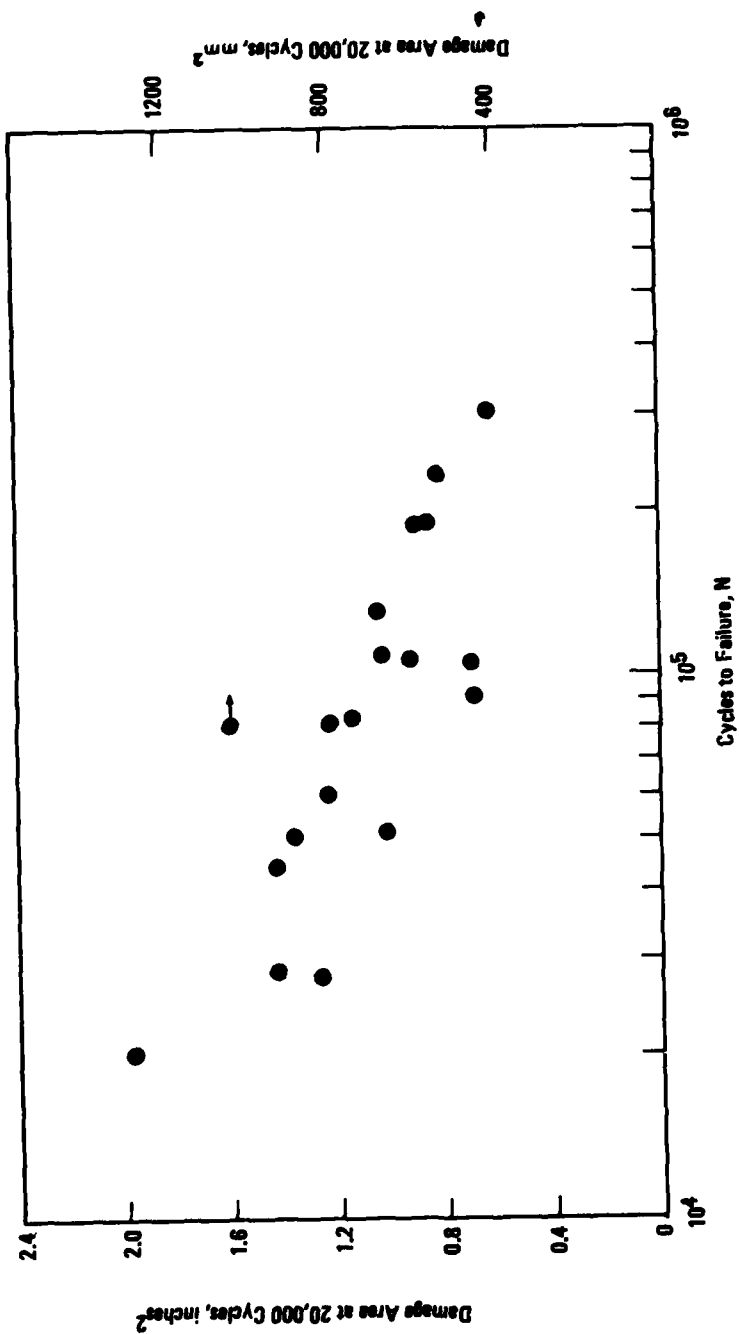
Figure 77: Damage Size at 20,000 Cycles vs. Life for the 32-ply Laminate

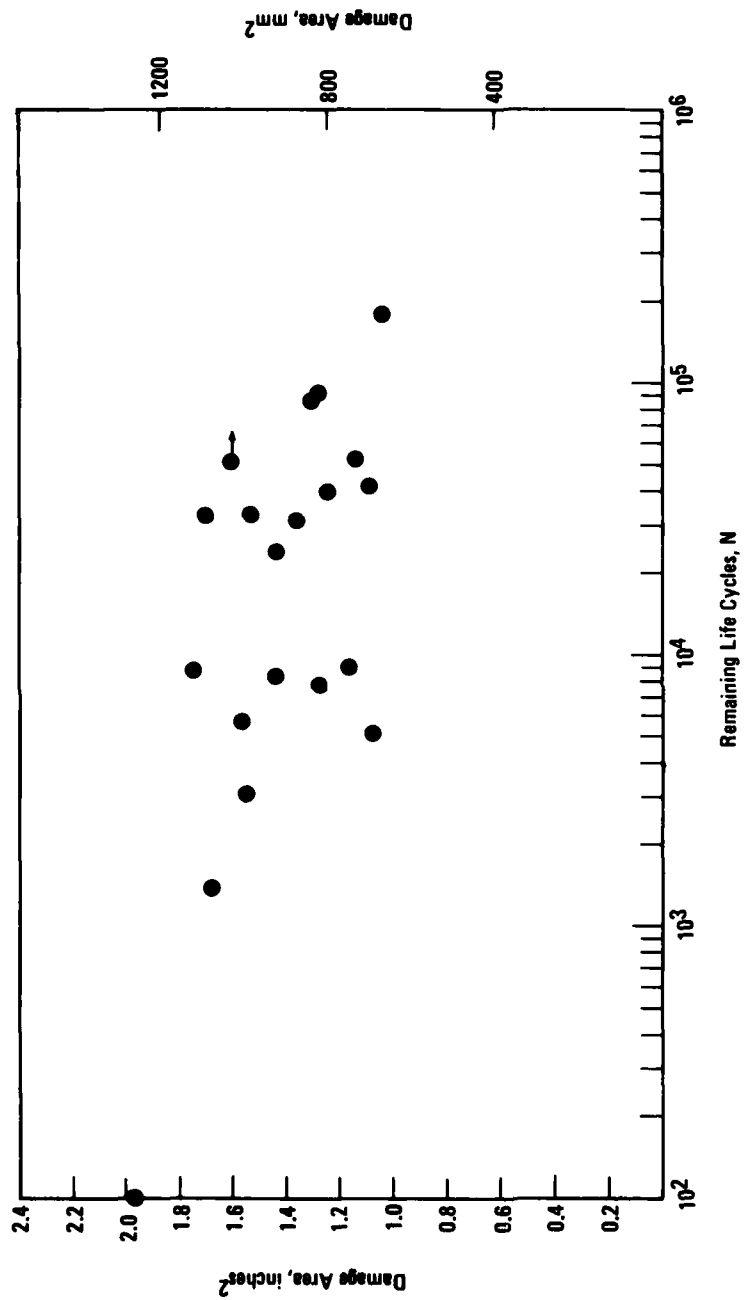
Figure 78: Last Recorded Damage Size Prior to Failure vs. Remaining Life for the 32-ply Laminate

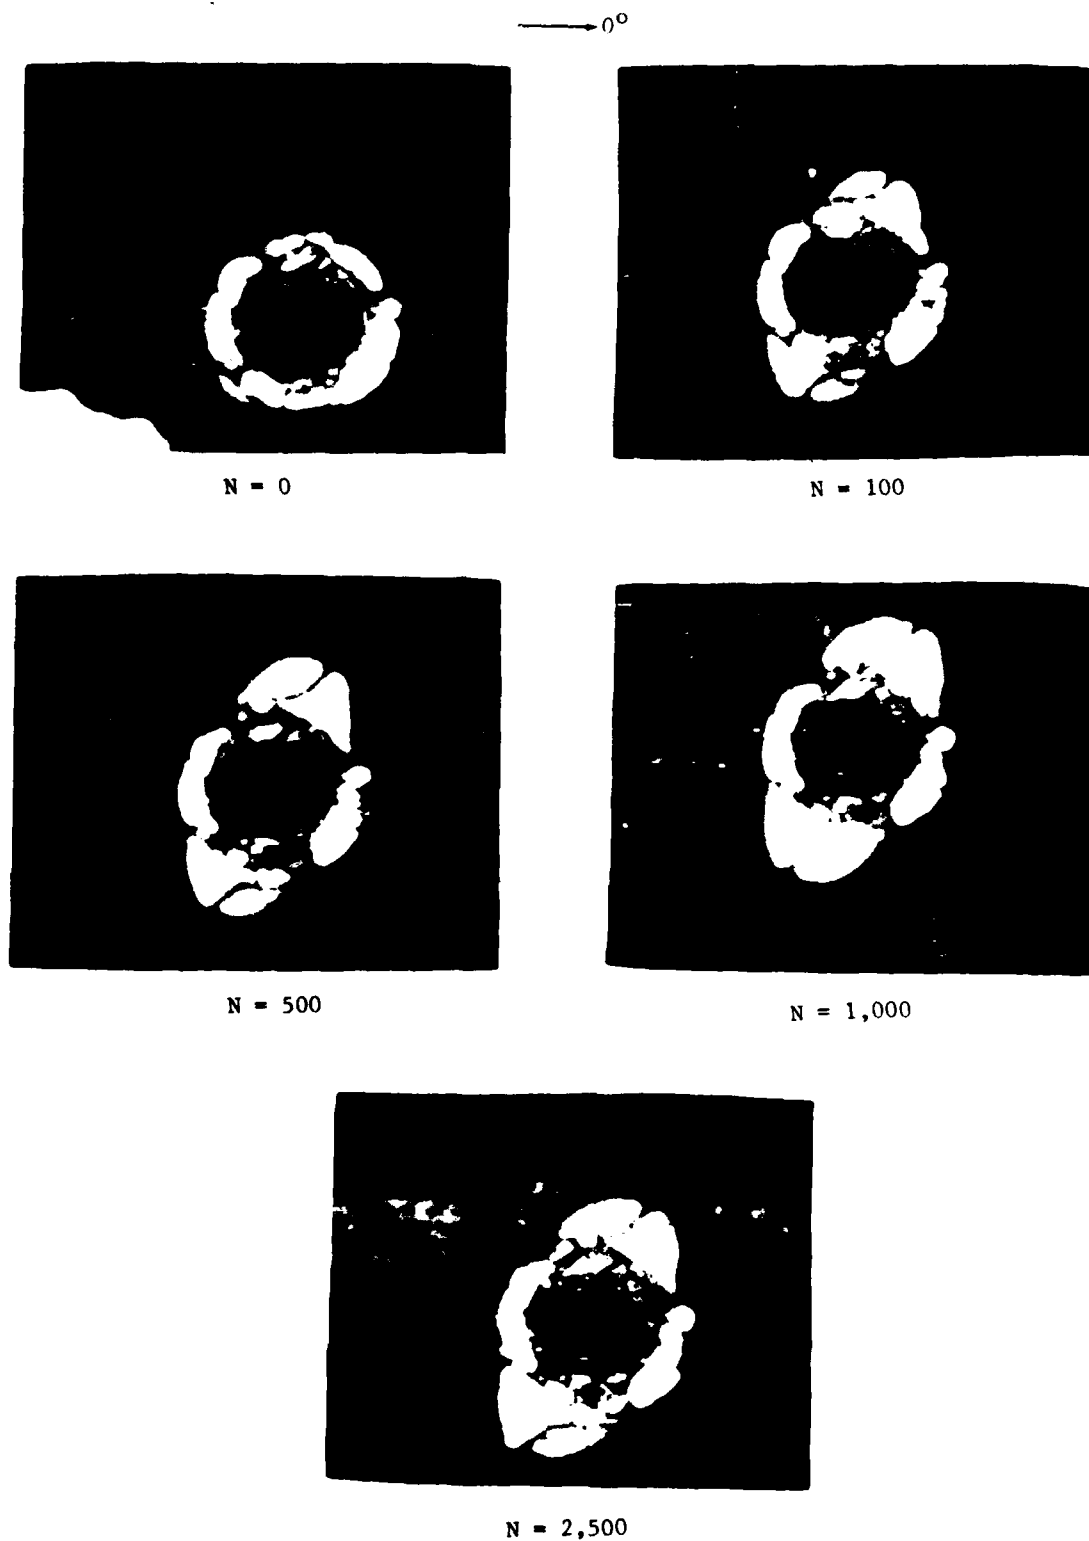
Figure 79a: Typical Damage Growth Characteristics of Initially Damaged 32-Ply Quasi-Isotropic Specimens (Specimen RB-14, $N_f = 51,400$)

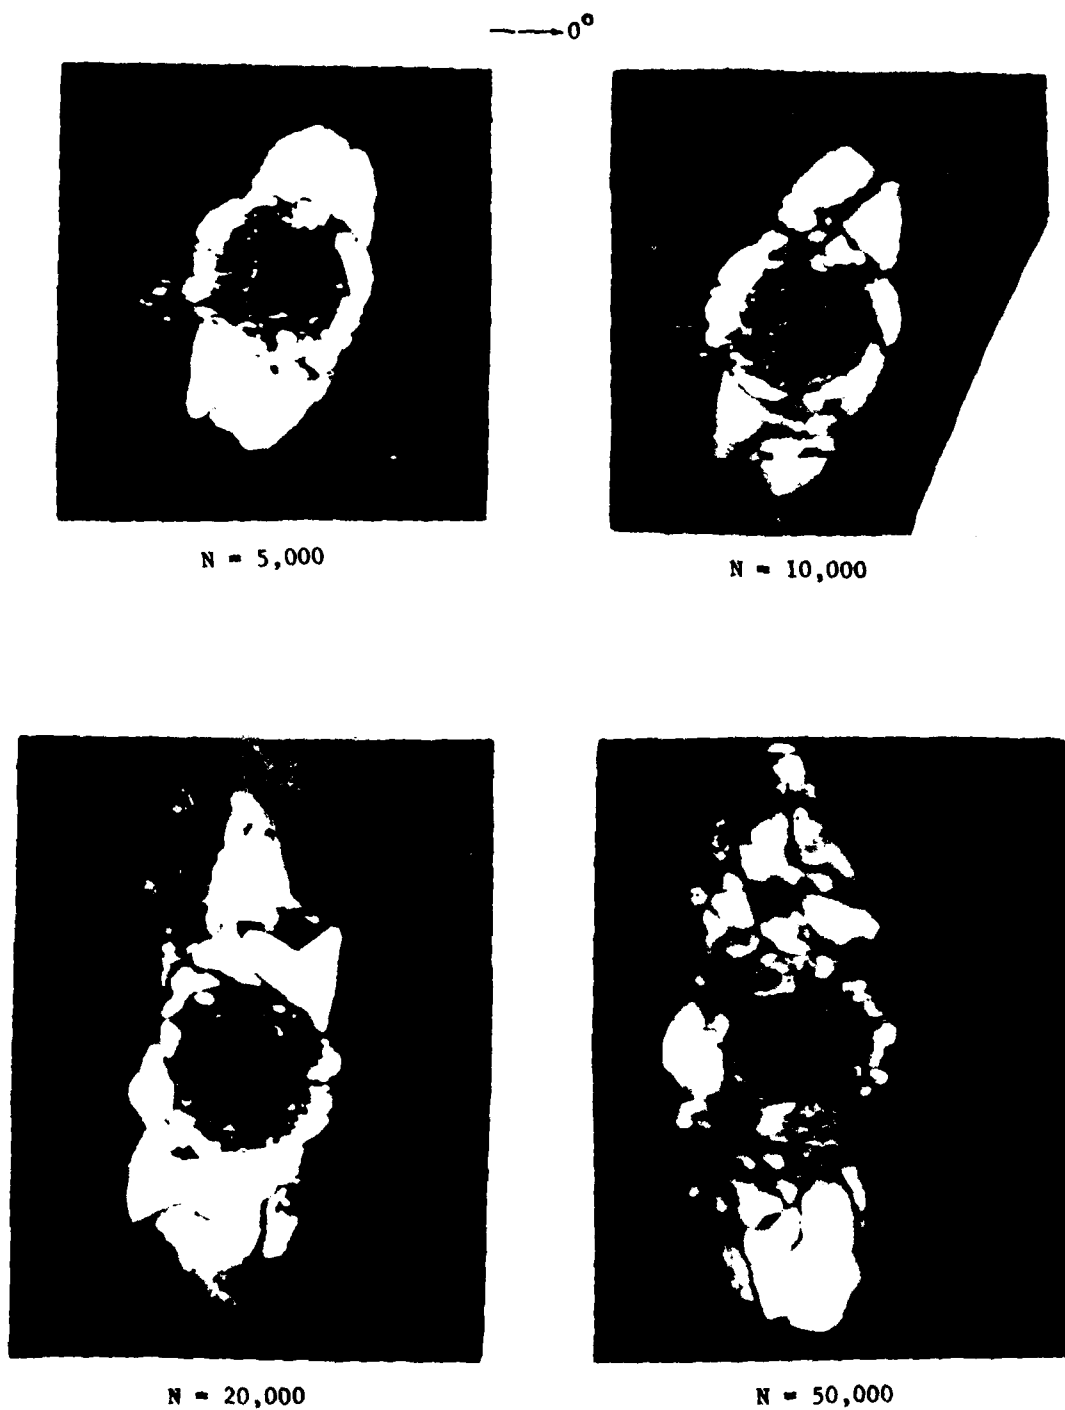
Figure 79b: Typical Damage Growth Characteristics of Initially Damaged 32-Ply Quasi-Isotropic Specimens (Specimen RB-14, $N_f = 51,400$)

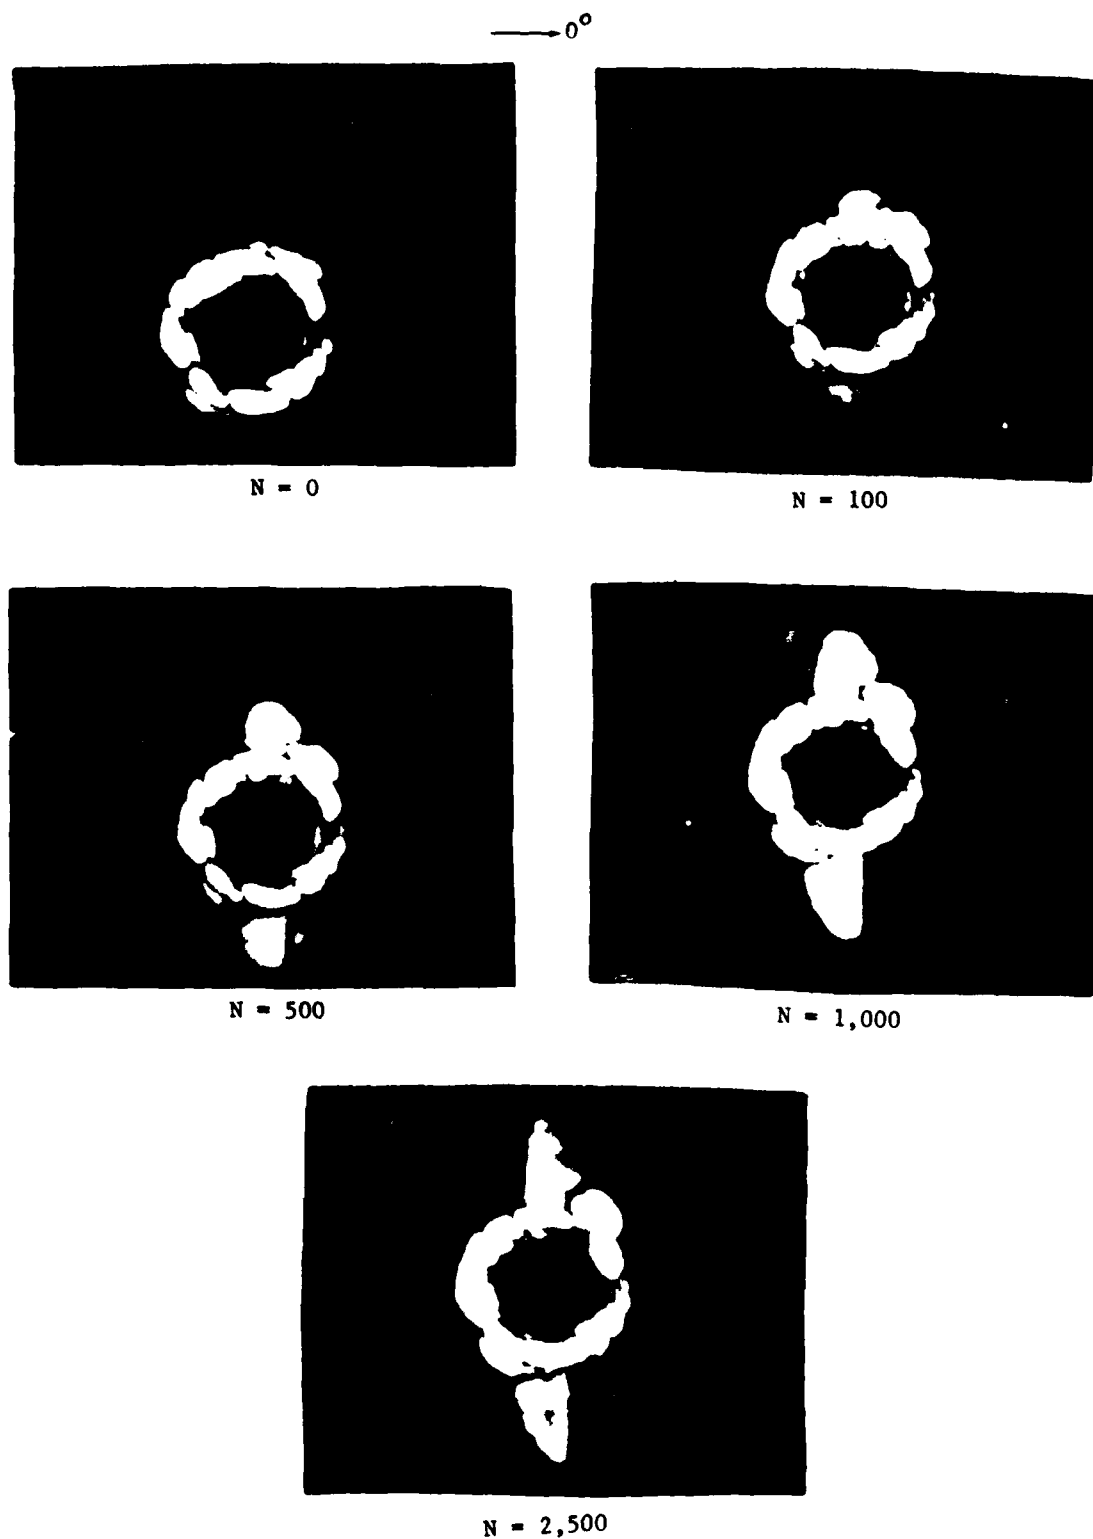
Figure 80a: Typical Damage Growth Characteristics of Initially Damaged 32-Ply Quasi-Isotropic Specimens (Specimen OA-5, $N_f = 234,200$)

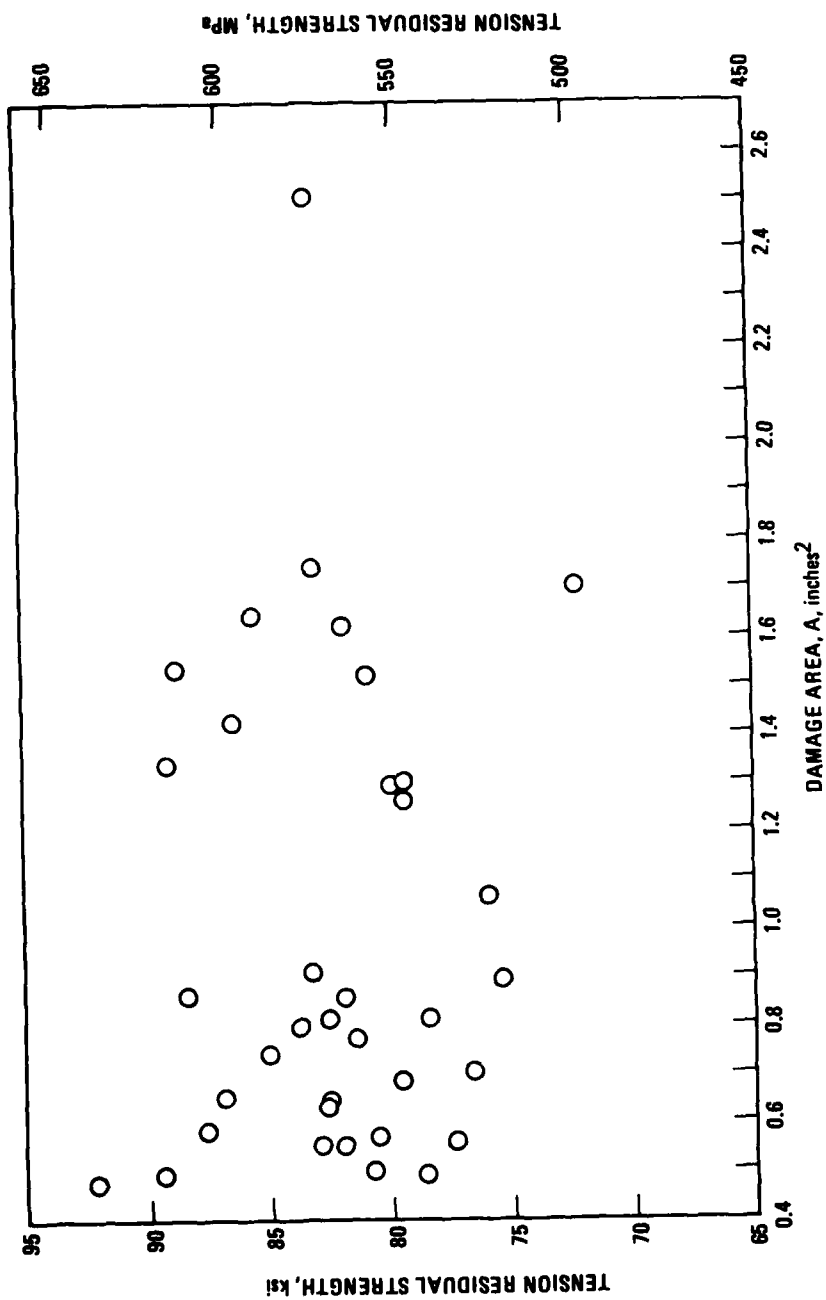
Figure 81: Relationship of Tension Residual Strength to Damage Area as Detected by the Holiscan Ultrasonic C-scan for 24-ply Laminated Specimens.

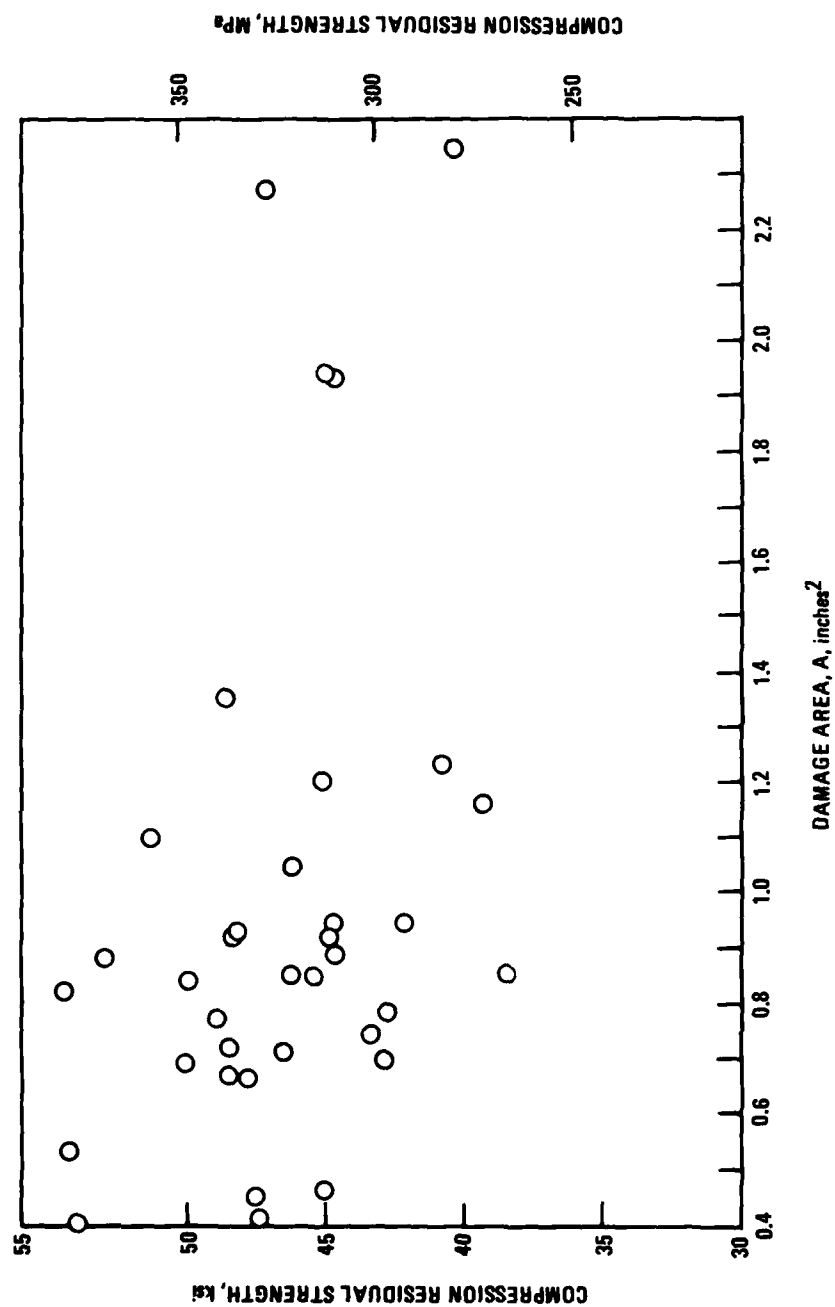
Figure 82: Relationship of Compression Residual Strength to Damage Area as Detected by the Holscan Ultrasonic C-scan for 24-ply Laminate Specimens

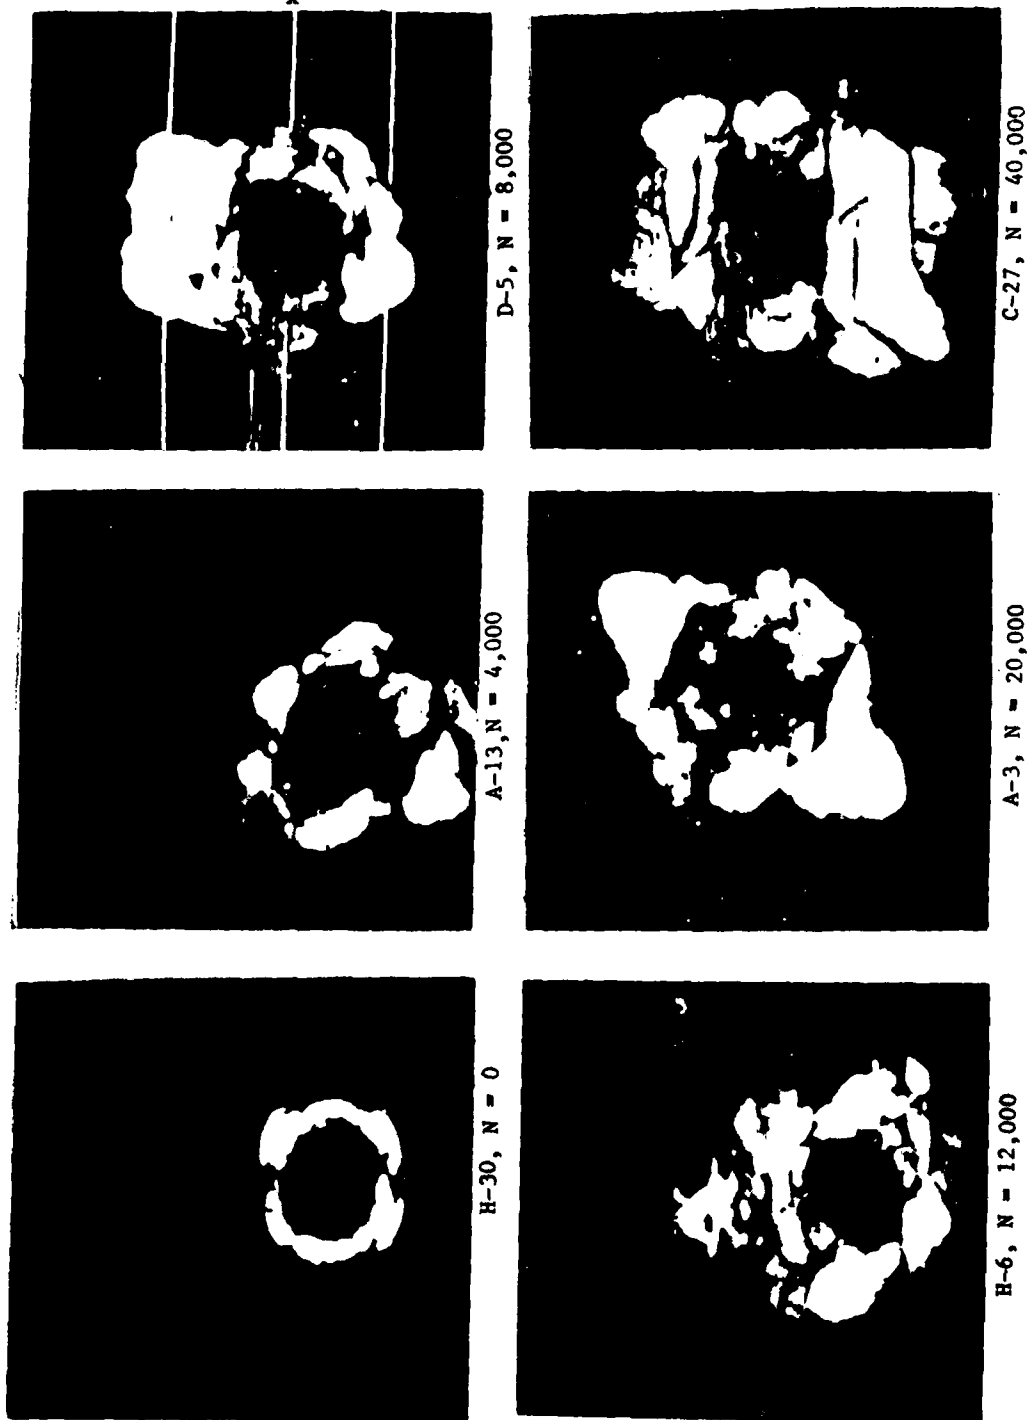
Figure 83: Typical Damage Characteristics of 24-Ply Specimens Fatigue Cycled at +35 ksi (+241 MPa) for Residual Strength Determination

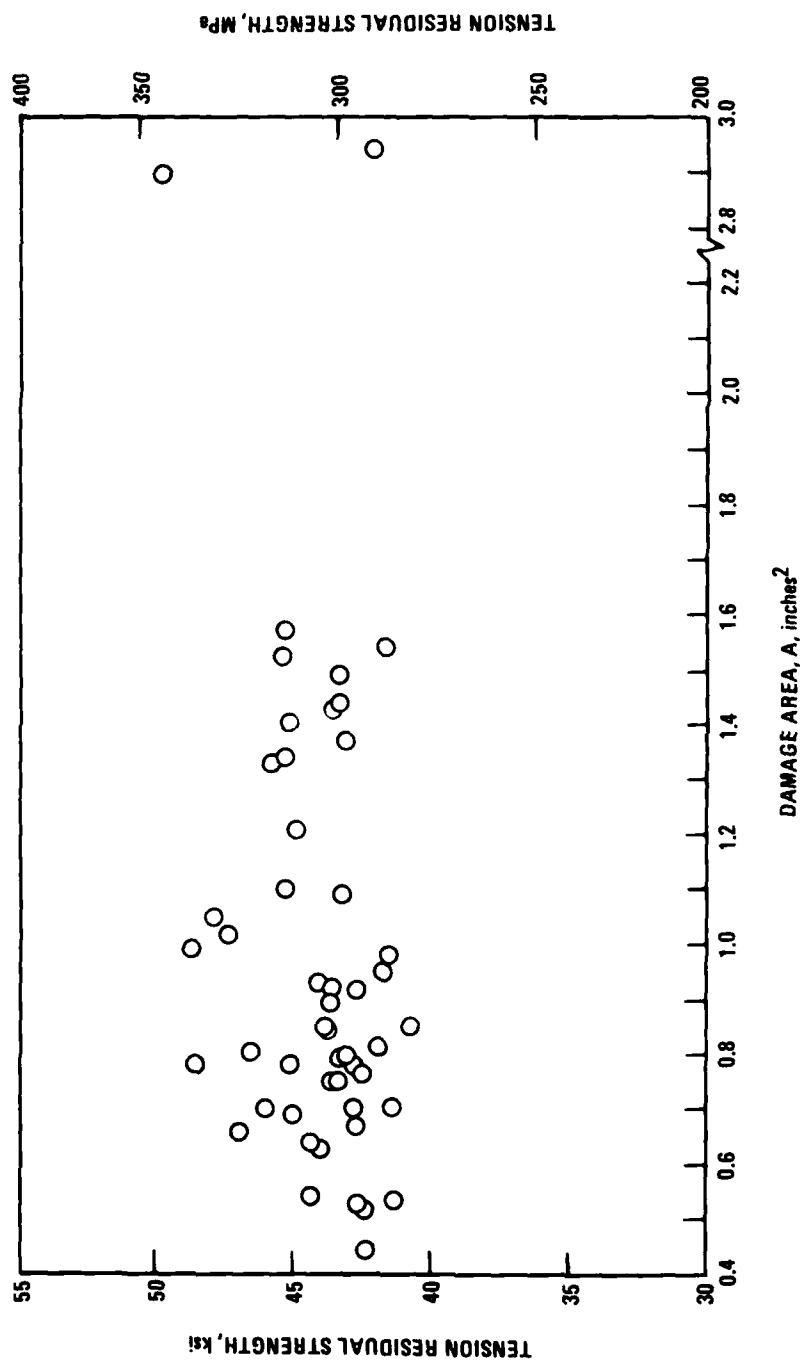
Figure 85: Relationship of Tension Residual Strength to Damage Area as Detected by the Holscan Ultrasonic C-scan for 32-ply Laminate Specimens.

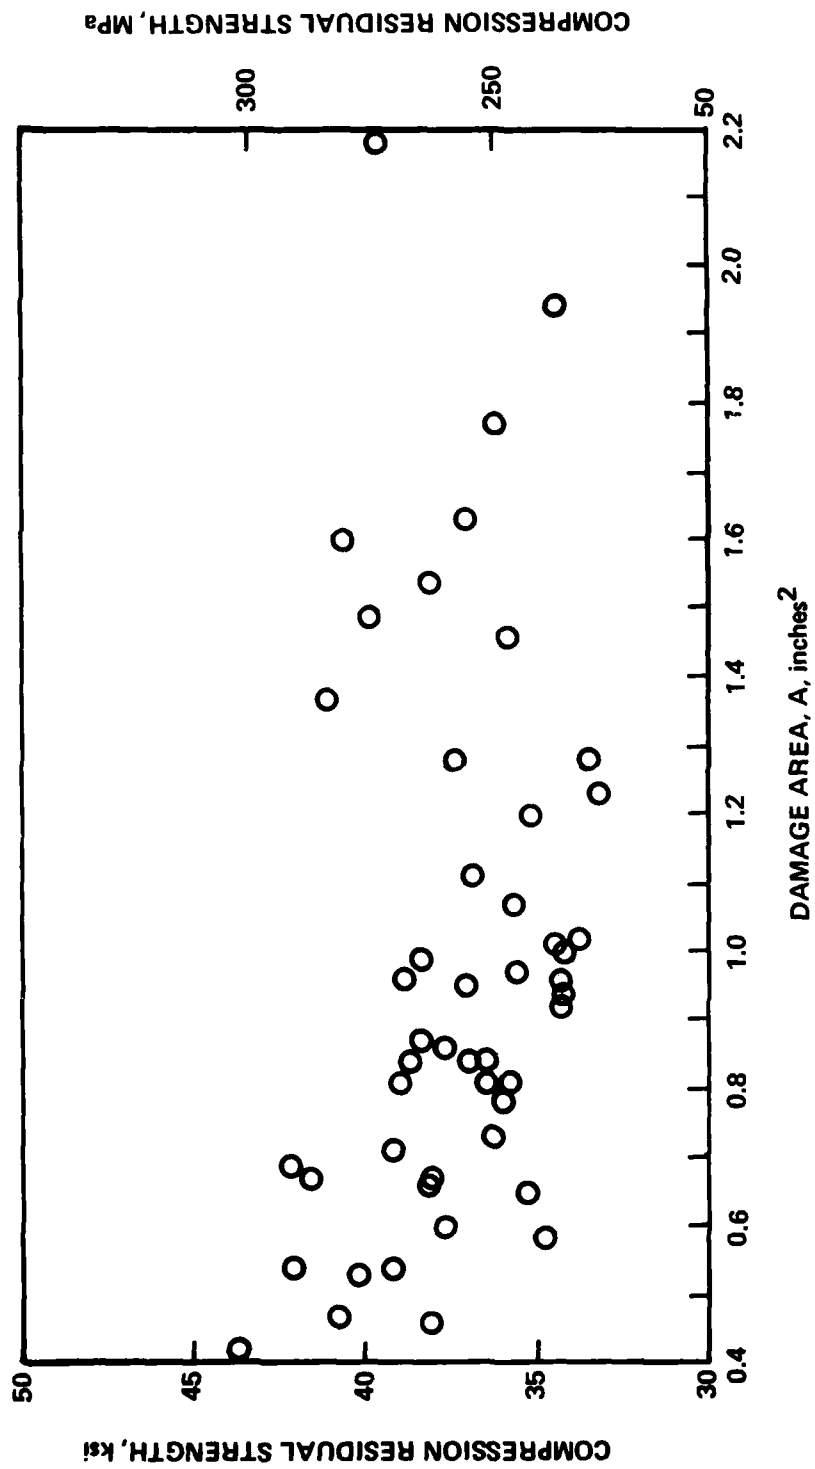
Figure 86: Relationship of Compression Residual Strength to Damage Area as detected by the Holscan Ultrasonic C-scan for 32-ply Laminate Specimens.

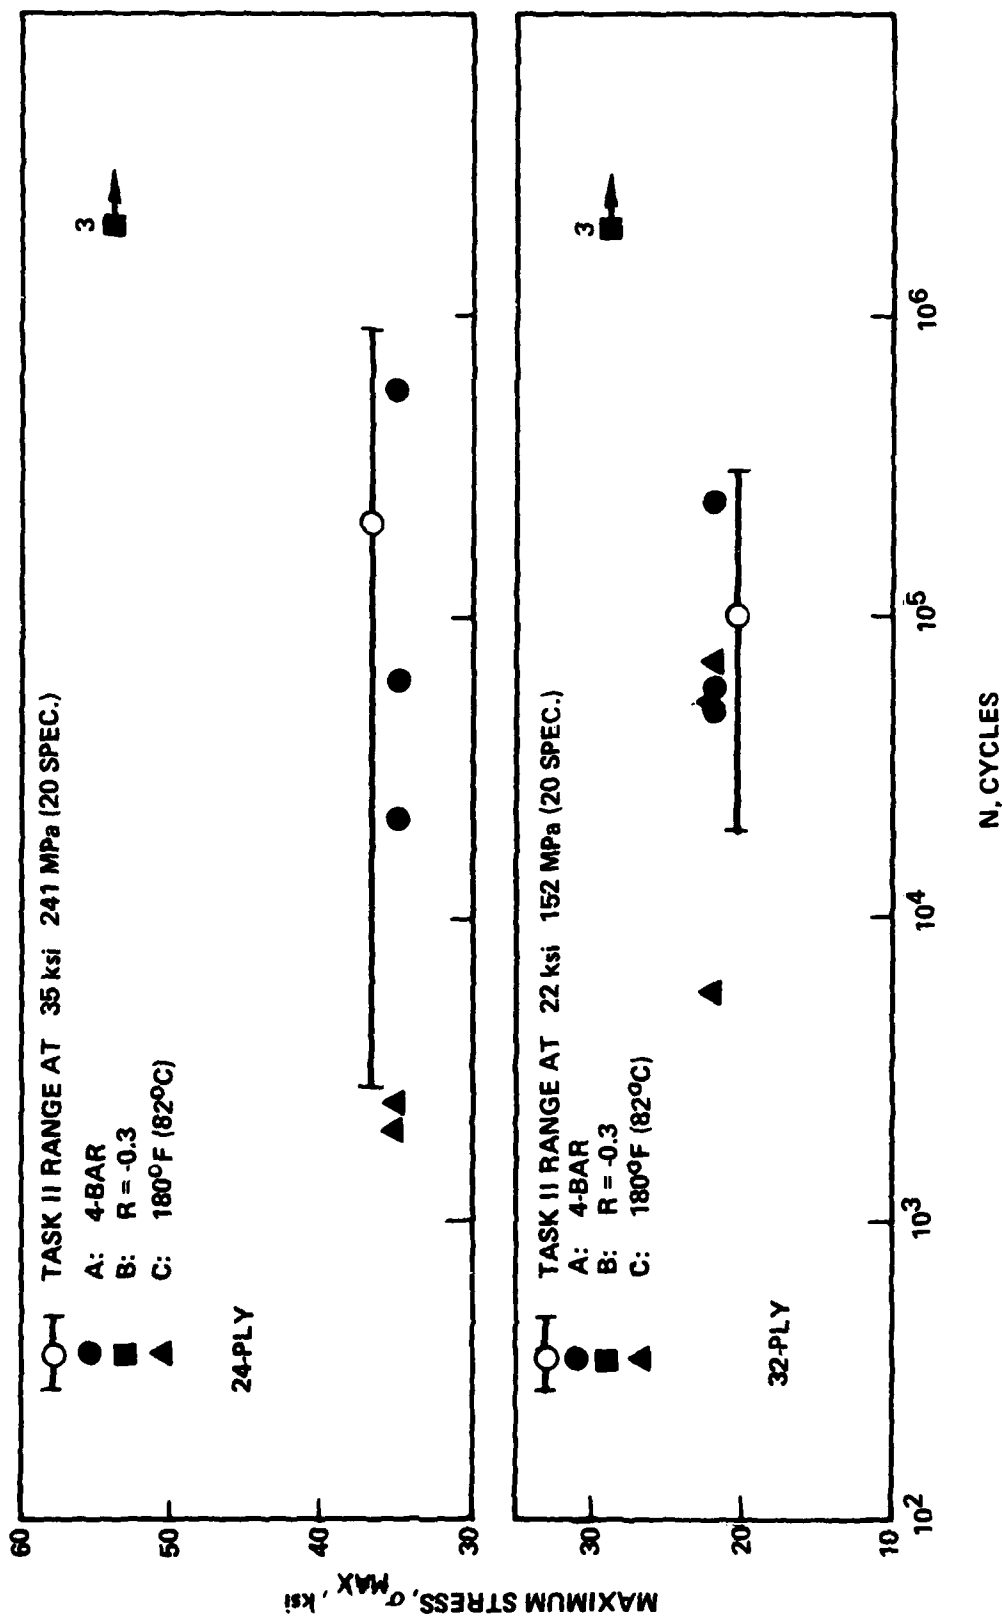
Figure 90: Fatigue Life Data for 24 and 32-Ply Laminates for Variations in Constraint Condition, Stress Ratio and Temperature Summarized in Table XXV.

Three replicates per each laminate for each of the fatigue cases (A, B, or C) were tested to discern the basic fatigue life and damage growth characteristics as determined at selected intervals during the life with the Holscan unit. Fatigue life data for these conditions are presented in Figure 90 and area damage growth results appear in Figures 91-96.

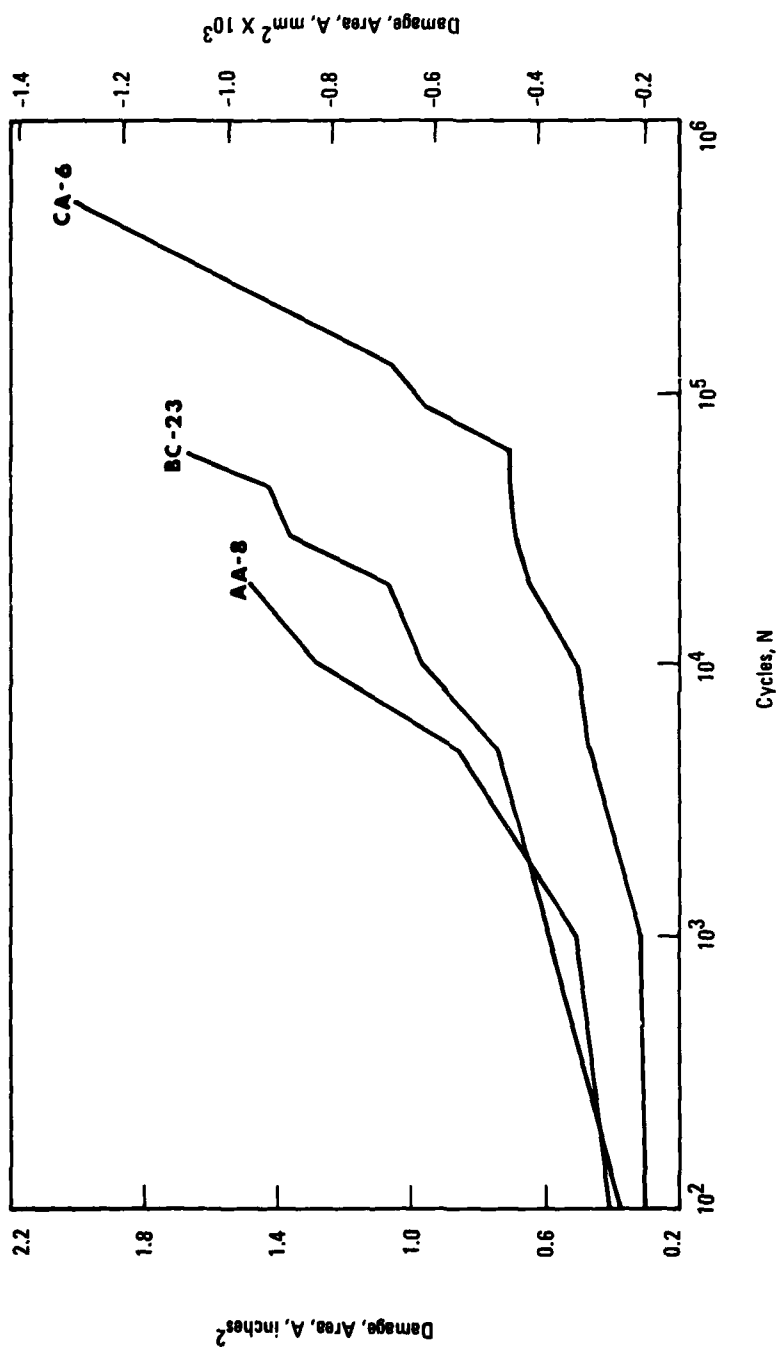
Figure 91: Area Damage Growth Behavior for 24-Ply Specimens, Case A (4-Bar).

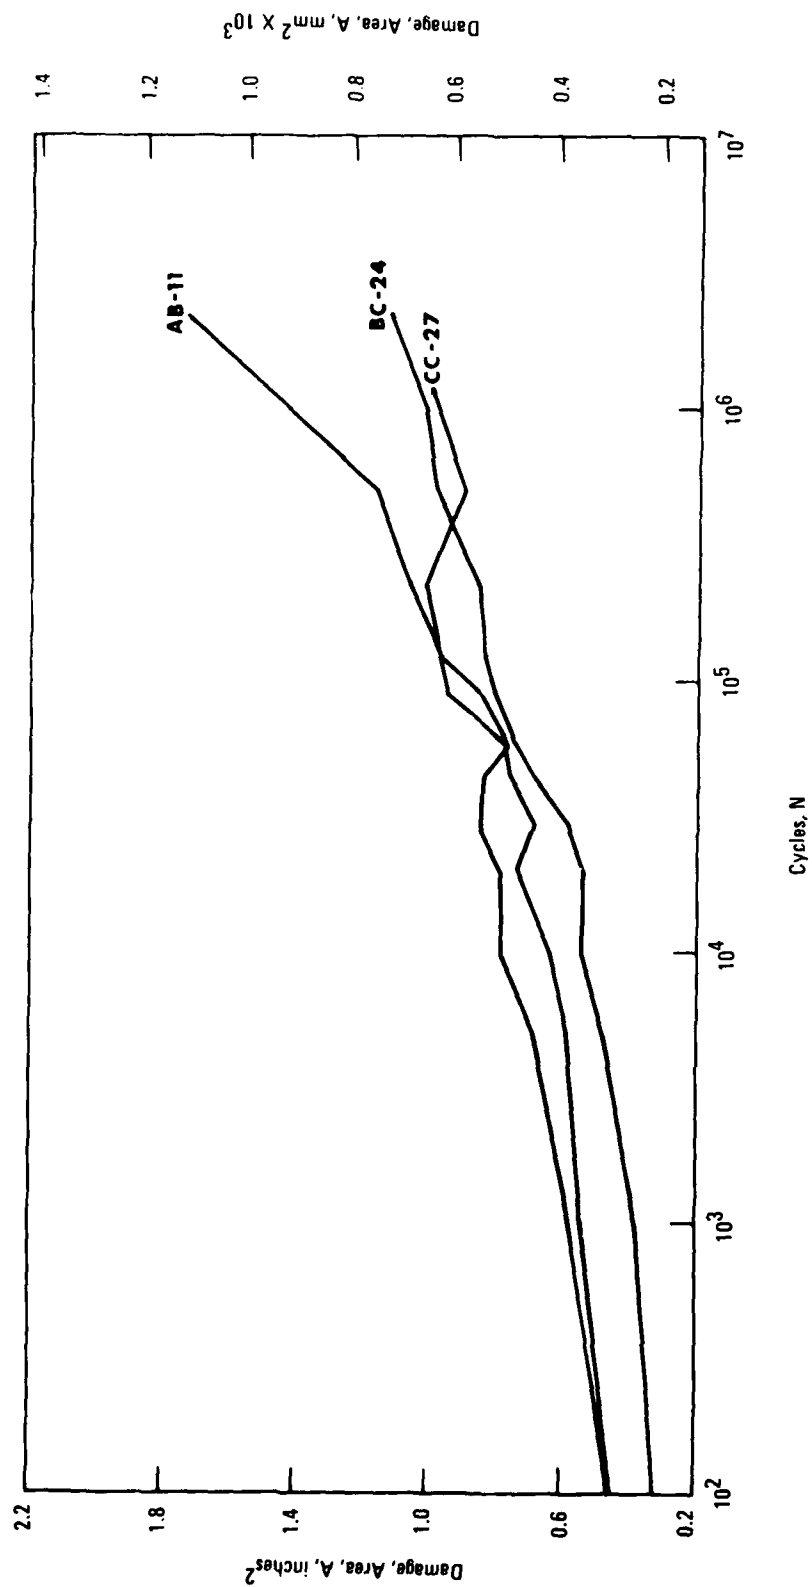
Figure 92: Area Damage Growth Behavior for 24-ply Specimens, Case B ($R = -0.3$).
